**“A \$150 Water Analysis Could Have Saved  
\$57,000 in Capital and RO Cleaning Costs”**

Joseph Urbans – Sales Engineer

*Res-Kem Corp.*

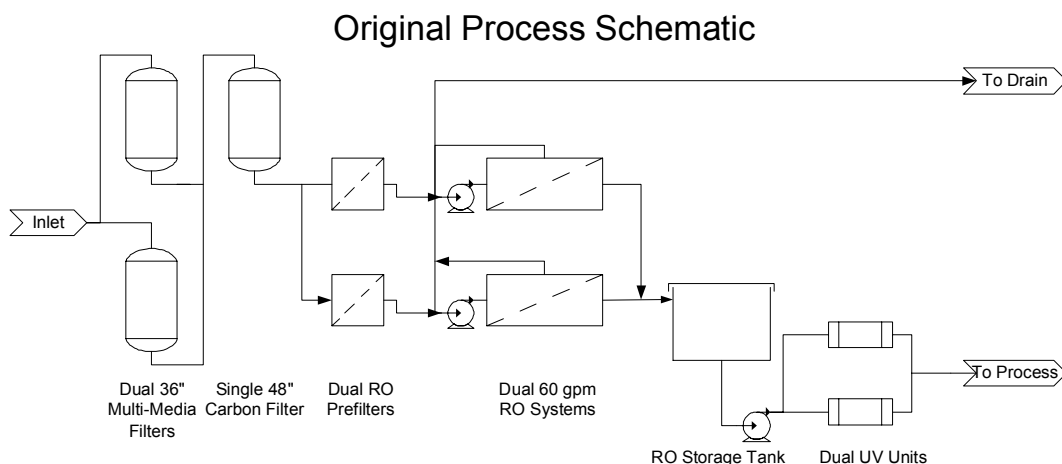
After spending \$52,000 in capital and installation for water treatment equipment, technical and service personnel from Res-Kem Corp were called in to diagnose a major problem with a three week old reverse osmosis (RO) system specified, built, and installed by others. Upon investigation, an inlet water analysis may never have been done, or at least no one could produce the analysis used to originally size the plant. It appears the engineering firm sized and designed this project without one.

The water system receives its raw water from common well system in an industrial park. This area is known for high iron content. The original RO pretreatment consisted of dual parallel operating 36-inch multi media filters followed by a single 48-inch activated carbon filter. Currently, the multi media filter and the carbon filter that are in service are being backwashed by the raw water so they're fouling their beds on the backwash cycle as well.
